Development Of The Strategy To Select Optimum Reflective Cracking Mitigation Methods For The Hot-mix Asphalt Overlays In Florida

A thesis submitted in partial fulfillment of the requirements
for the degree of Master of Science
in the Department of Civil, Environmental, and Construction Engineering
in the College of Engineering and Computer Sciences
at the University of Central Florida
Orlando, Florida

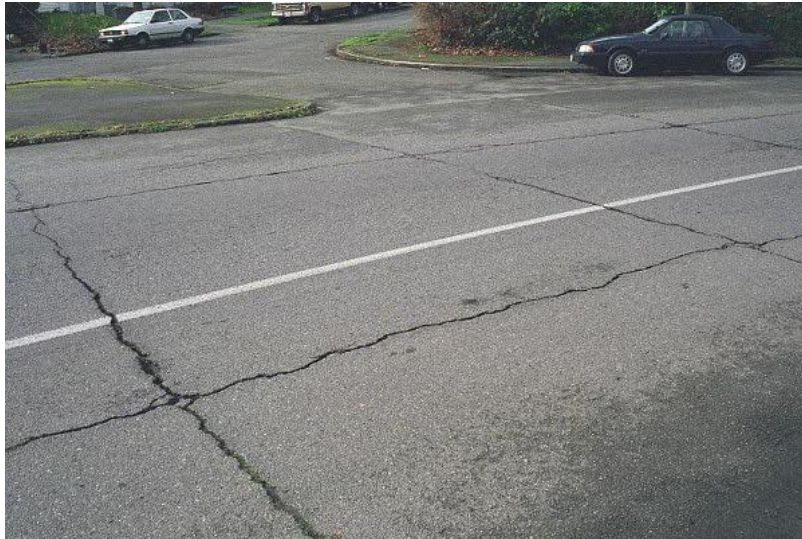
Figure 1. 1 Joint Reflective Cracking

Reflective Cracking (RC) can be formed when a Hot Mix Asphalt (HMA) overlay is placed on jointed or severely cracked rigid or flexible pavements (see Figure 1.1). Creation of the RC on the HMA overlays can further develop other pavement distresses such as stripping and weakening sublayer materials (base, subbase, and subgrade) by allowing moisture infiltration. Therefore, there have been many attempts to prevent or retard the initiation of the RC on HMA overlay. The range of success for various projects is from failure to very successful depending on site condition along with a selected RC mitigation technique.

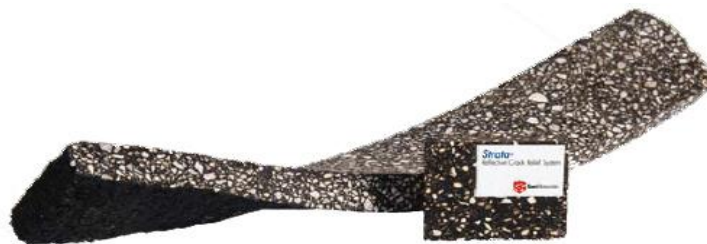
RCRI (or Strata) system is another type of SAMI which utilizing Styrene-Butadiene-Styrene (SBS) polymer Instead of using rubber. Figure 2.7 shows a sample of RCRI. RCRI consists of highly polymer modified asphalt binder and fine aggregates. High binder content makes layer more flexible and enables the layer to resist tensile stress and strain under thermal expansions and contractions. This interlayer is normally 25 mm (1 in) in thickness. Experimental results show the crack resistance improves by increasing the thickness and stiffness of the overlay and reducing the stiffness of the membrane layer (Von Quintus, 2009).

Figure 2. 7 Reflective Cracking Relief Interlayer or Strata (Pavement Performance Prediction Symposium, 2007)
